# **Water in Fuel / Non-Warrantable Fuel System Repair Job Aid**

## **Introduction**

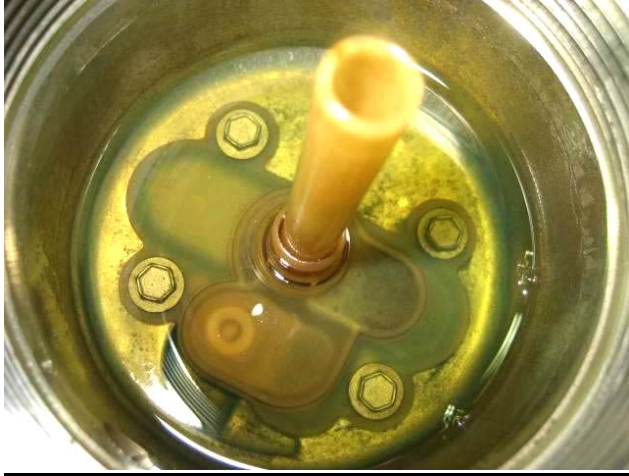
Figure 1

## Rust and Corrosion in Secondary Fuel Filter Housing

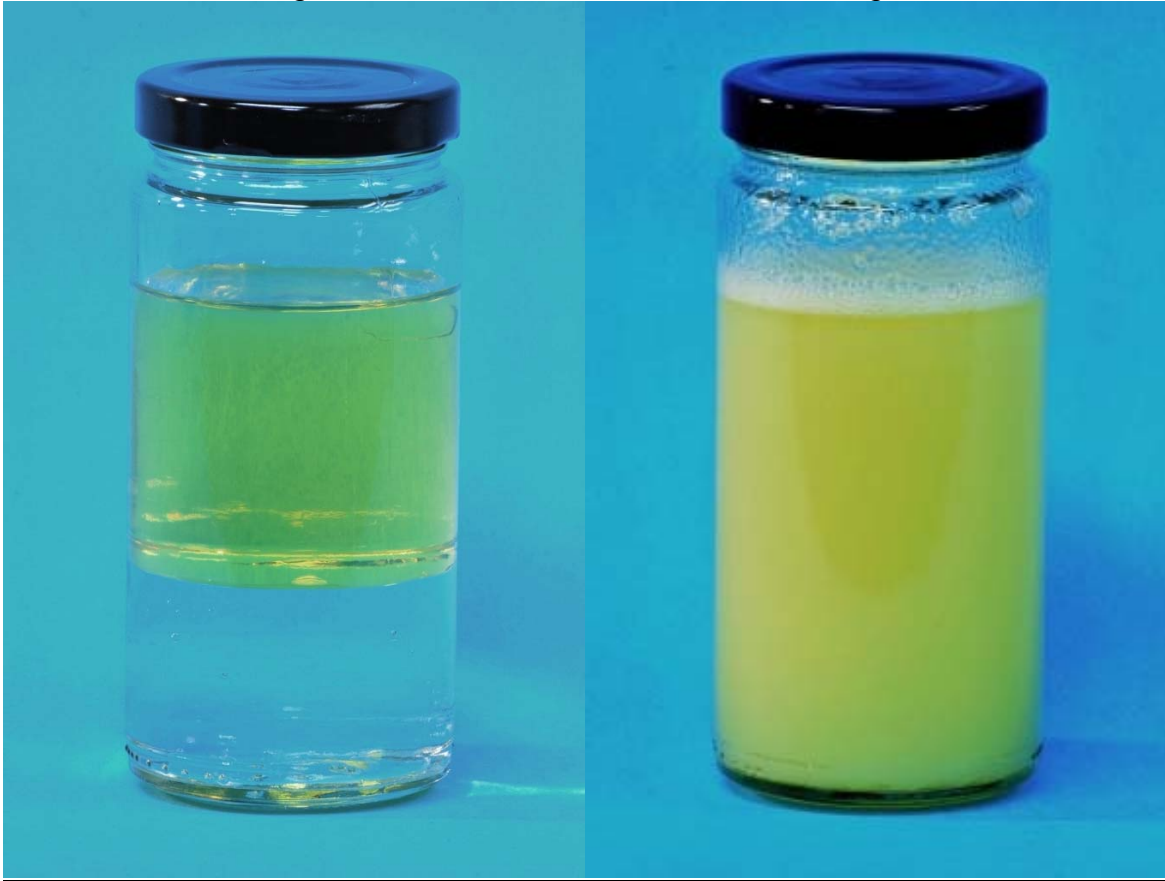
- Secondary fuel filter housing—filter removed (Figures 1-4)
- Visual appearance of fuel from the secondary filter housing
  - Standing water (Figure 5)
  - Cloudy—emulsified water and fuel (Figure 6)
- Primary and Secondary fuel filters

## Water-in-Fuel Contamination

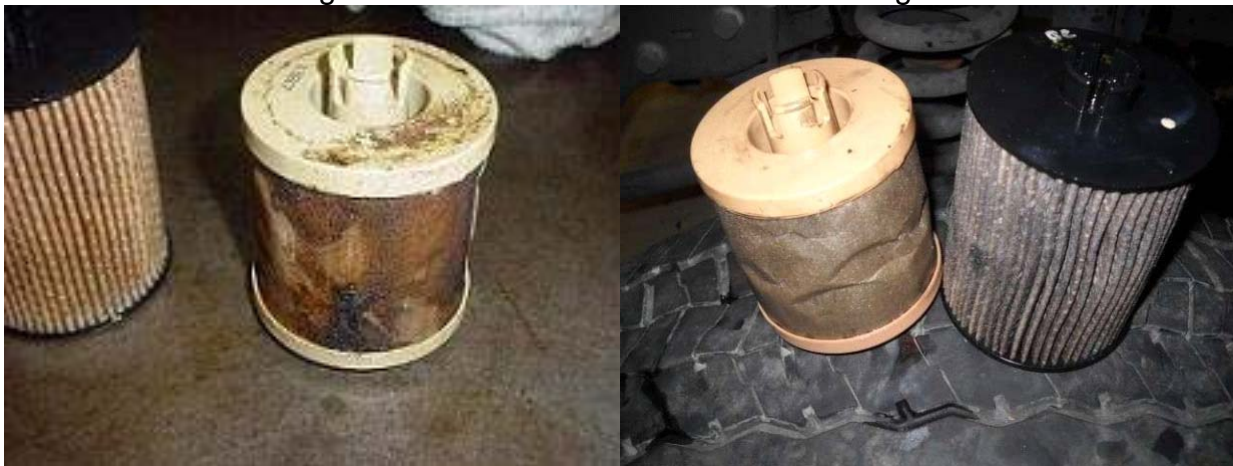
Insufficient fuel filter maintenance may affect the ability of the fuel system to separate water from fuel.

## Primary and Secondary Fuel Filters – Insufficient Maintenance

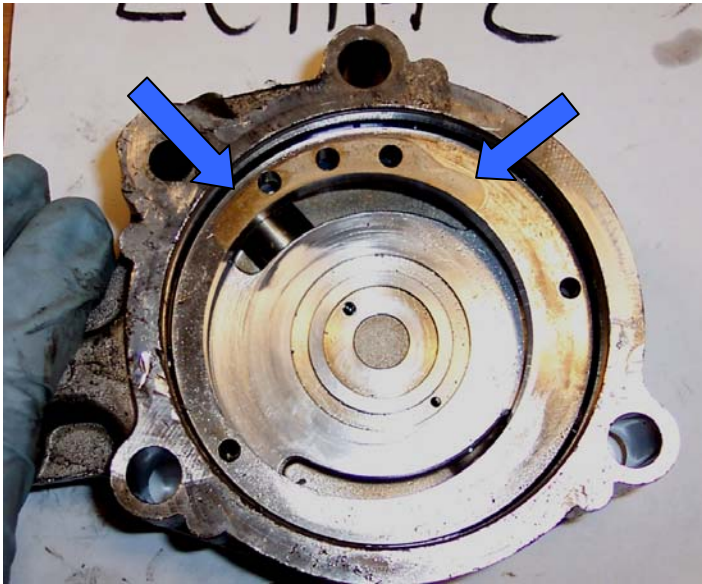
Figure 10

The Internal Transfer Pump (ITP) is located inside the High Pressure Fuel Injection Pump. Physical inspection of the ITP for rust or corrosion is required to determine fuel system warranty eligibility. Rust/corrosion within the ITP is confirmation of fuel system damage due to water/contaminated fuel. Fuel system damage due to water/contaminated fuel is not eligible for warranty coverage. Refer to Warranty and Policy Manual for additional information.

## Corrosion under the Internal Transfer Pump Cover

Fuel system components to be replaced when rust/corrosion is found in the ITP inspection:

Part Number (Qty)	Part Common Name	* Kit contains
9A543 (1)	High Pressure Pump assy	N/A
9G805 * (1)	High Pressure Pump gasket kit	<ul style="list-style-type: none"> <li>▪ High pressure pump gaskets</li> <li>▪ High pressure pump-to-fuel rail manifold fuel lines</li> </ul>
9N103 (1)	Fuel Cooler assy	N/A
9H529 * (8)	Fuel Injector kit	<ul style="list-style-type: none"> <li>▪ Fuel injector</li> <li>▪ Jumper tube</li> <li>▪ Fuel injector gaskets</li> </ul>
8C3Z- 9T287-CA * (1)	LH and RH Fuel Rail Manifold kit	<ul style="list-style-type: none"> <li>▪ LH fuel rail manifold</li> <li>▪ RH fuel rail manifold</li> </ul>
9N184 * (1)	Fuel Filter kit	<ul style="list-style-type: none"> <li>▪ Primary fuel filter</li> <li>▪ Secondary fuel filter</li> </ul>
9G756 (1)	Fuel Pressure Sensor	N/A
9C330 (1)	Fuel supply line	N/A
9C148	Secondary fuel filter housing	N/A
