# **Water in Fuel / Non-Warrantable Fuel System Repair Job Aid**

## **Introduction**

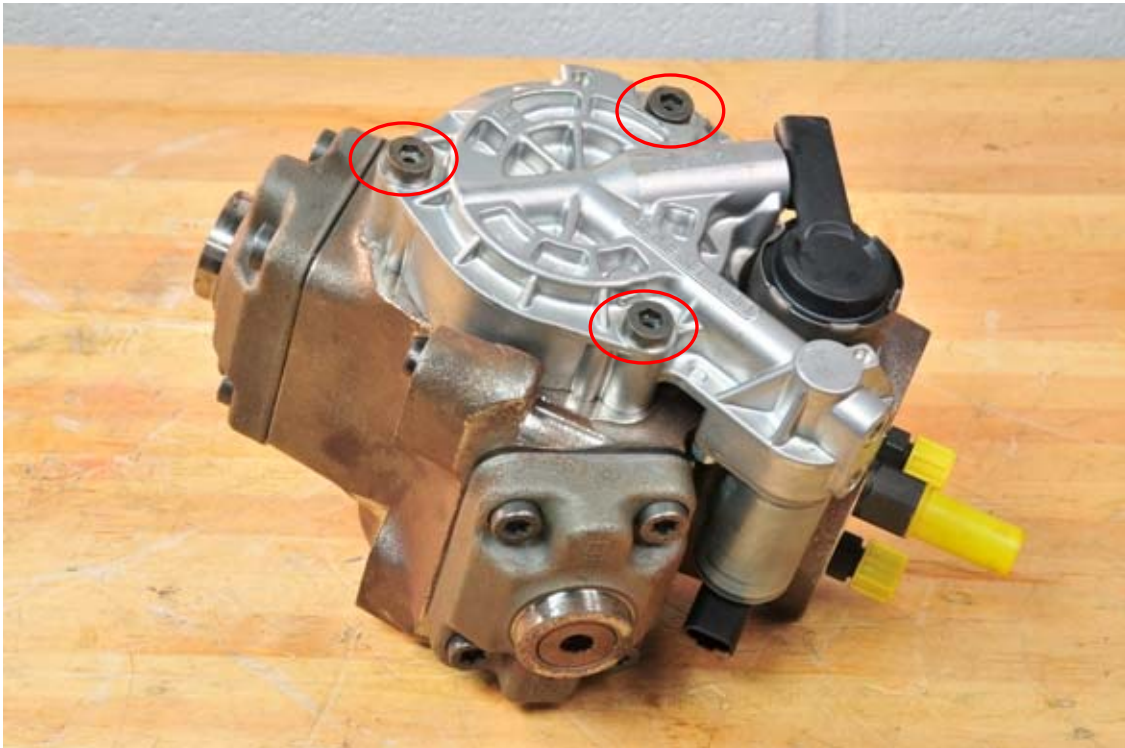
Figure 9

1. Remove the High Pressure Fuel Injection Pump. Refer to WSM, Section 303-04.
2. Place the pump assembly on a bench with the ITP cover facing up. (Figure 9)
3. Remove the 3 fasteners (6mm hex) and the ITP cover.
